Model: All '11MY Federal Elise/Exige Models

Number: 2014/03
USA

Installation of new software into '11MY Elise/Exige I.P. (Instrument Pack) and any Aftersales service replacements fitted to '08 - '10MY vehicles as required.

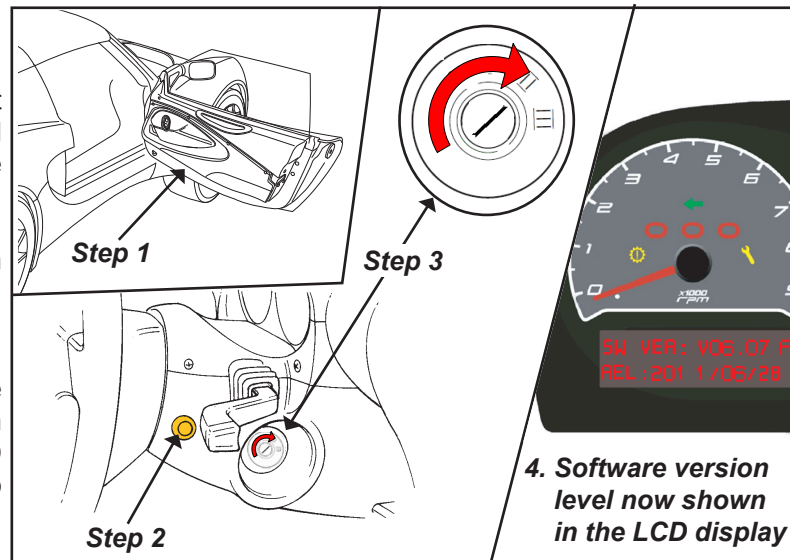
1. Open the driver's door.
2. Push in and hold the instrument panel illumination button located on the right hand side of the steering column shroud.
3. While holding in the illumination button, turn the key to the IGN ON (position 2).
4. The currently installed software level version will be shown on the top left hand side of the LCD display in the place of the trip meter, i.e., VER.6.03 or 5.05.

If SW VER: V06.07 is displayed, the latest software is already installed and the update process is not required, but if the campaign action is shown as outstanding on DC611 for the specific VIN then a claim for verifying the software level may still be submitted (see 'CHARGES' section on page 5 for further information).

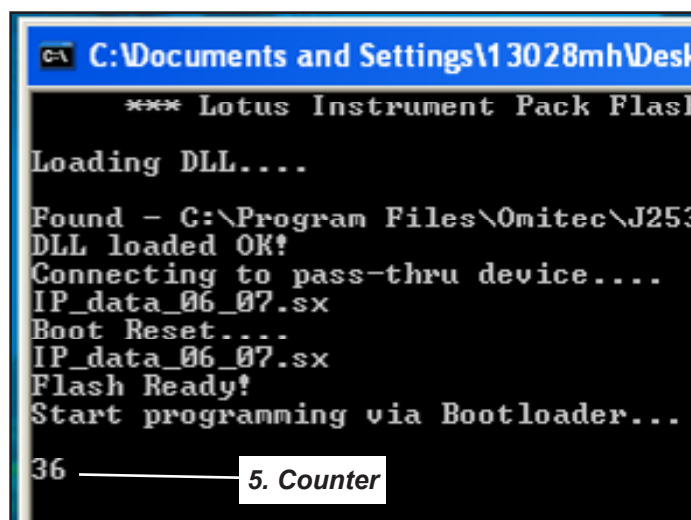
5. The following loading screen will appear and note the "Success" messages in the screen. The counter in the middle of the screen will start at zero and count to 1018 within approximately 3 to 4 minutes.

WARNING: Do not touch the keyboard or interrupt the process, wait for the counter to reach 1018. Interrupting the download process will damage the instrument pack!

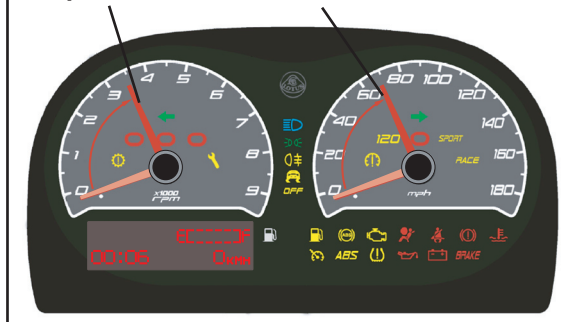
6. Speedometer & tachometer needles

6. After 3 to 4 min (Approx) and the counter reaching 1018, the speedometer and tachometer needles will sweep indicating the software update procedure is complete.
7. Disconnect the VCD from the computer and the vehicle.
8. Check new software has loaded successfully by doing a software level version check again as described on page 2 of this bulletin.
9. The software level version shown on the LCD display should now show – SW VER: V06.07
